Repairing and protecting concrete

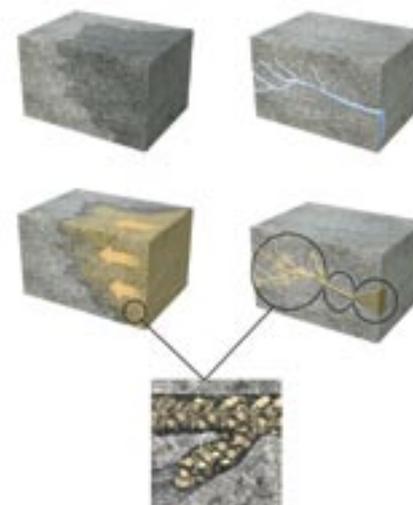
Crystallization penetrates the concrete through the capillary power in pours and cracks in order to stop further leakage. The chemicals crystallize (these are non-poisonous and are approved as drinking water) and prevent the spread of moisture within the concrete.

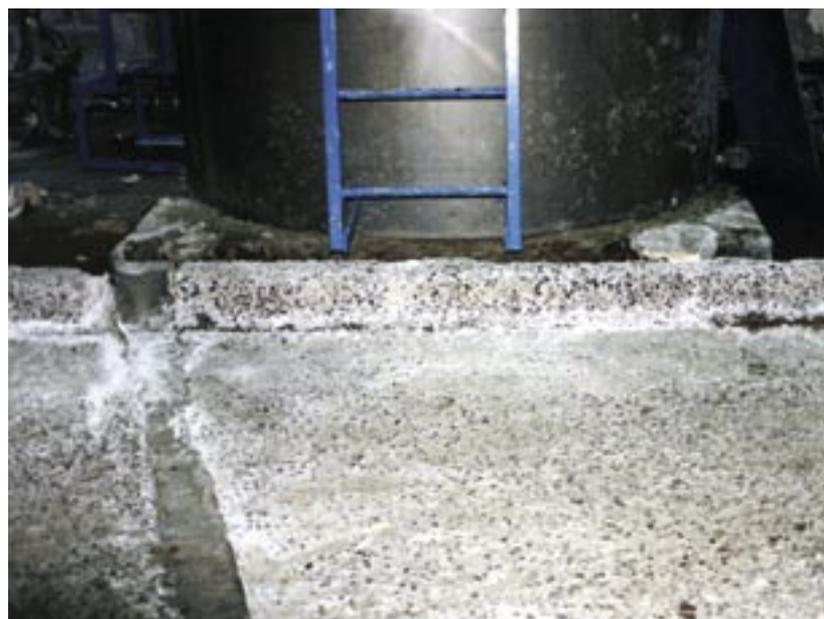
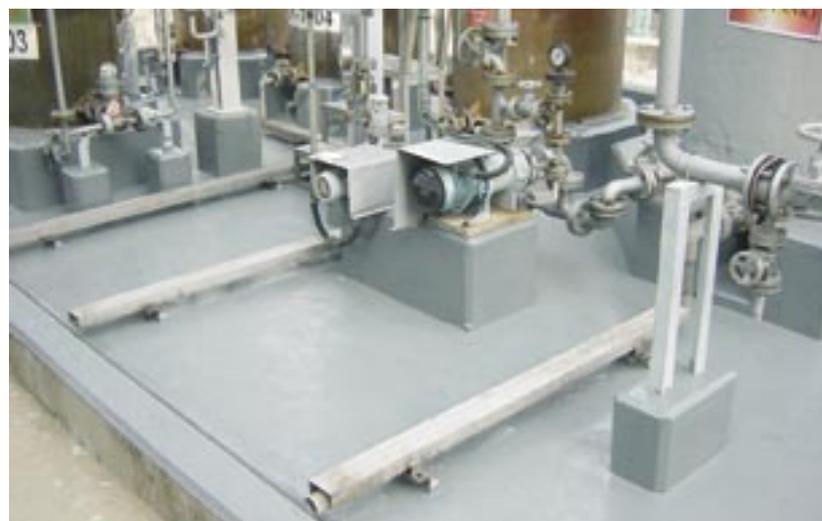
The concrete is often exposed to and demolished by aggressive chemicals.

A number of different materials have been used to protect the concrete but most of these have not been good enough. Today, products and methods have been developed to withstand most of the chemicals that are used in the industry, up to 200°C

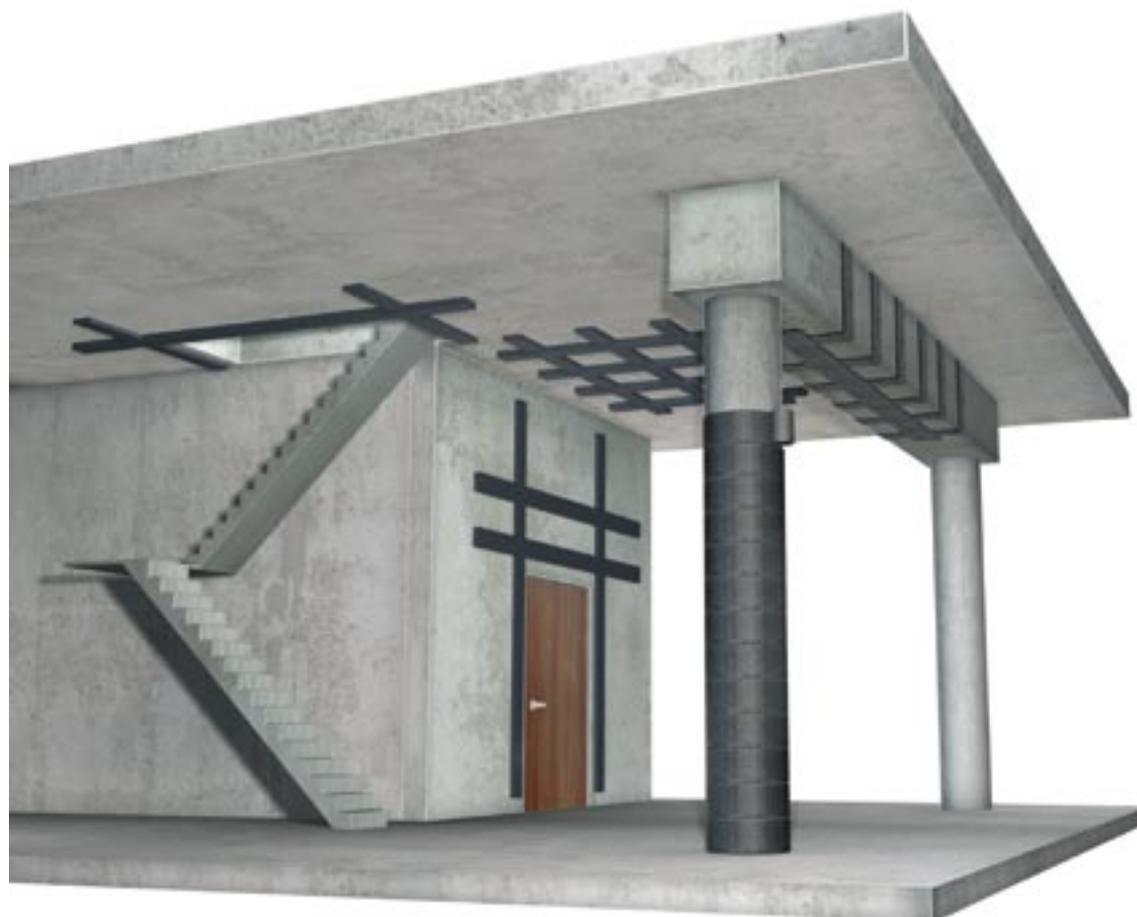
The illustration shows where carbon fibre composites can be used to strenghtening concrete constructions.

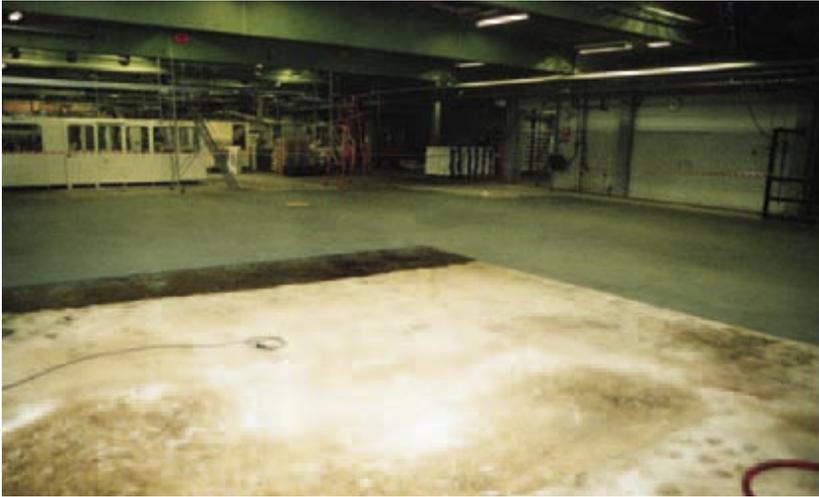
THE PICTURE shows a floor that is exposed to many different kinds of media and varied temperatures.

It is very important to carry out a detailed examination of the floor in order to see what the floor has been exposed to and what kind of chemicals it will be exposed to in the future. After the examination we are able to recommend the right product and the right surface preparation.

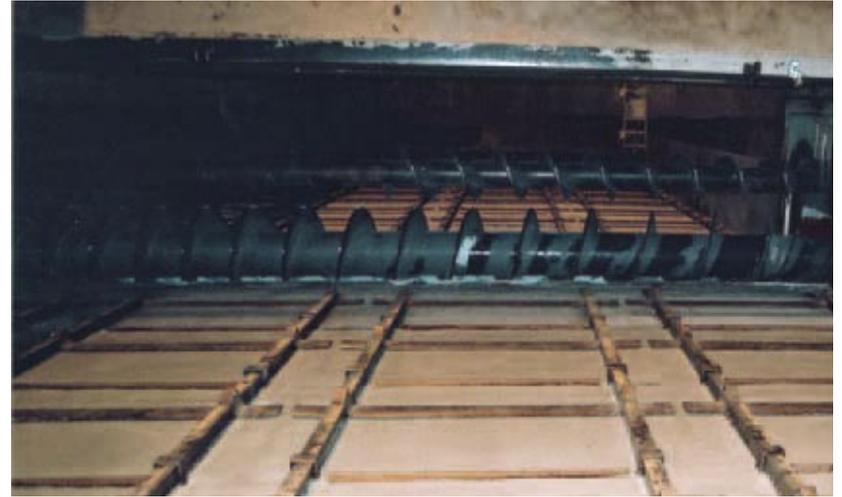
The outer area in the chip bins consists of concrete or is lined with steel. Various types of media such as chips, bark, bark acid, forest residue, etcetera, causes heavy wear. Together with our customers we have discovered that there is an unnecessarily high number of break downs and maintenance, the reason being that the wrong material was used in the chip bins.

Composite technology has shown to be suitable for reparation and upgrading of the chip bins within the concrete. The right products adhere to damp concrete and resist the wear and acid attack in these areas.

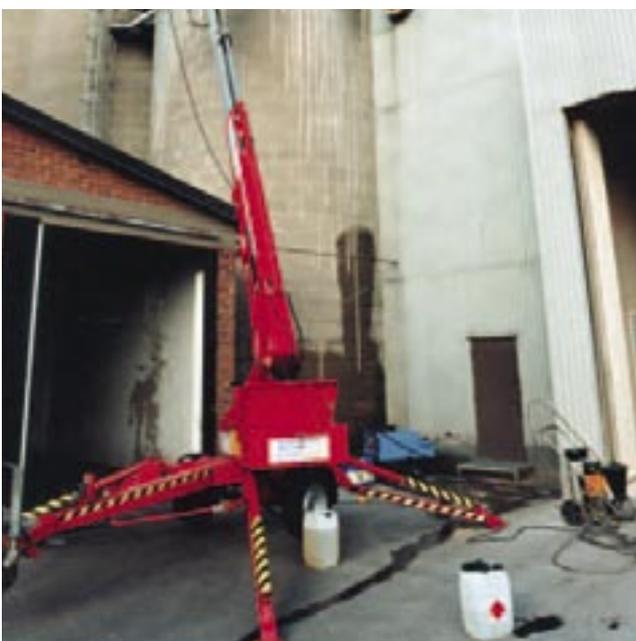
Silos, chimneys, water towers, walkways and other buildings/constructions carbonate because of weather, acid rain, chlorides, etcetera. It is important to protect the assets by cleaning, repairing and shielding in time, before much larger and more costly repairs have to be carried out.

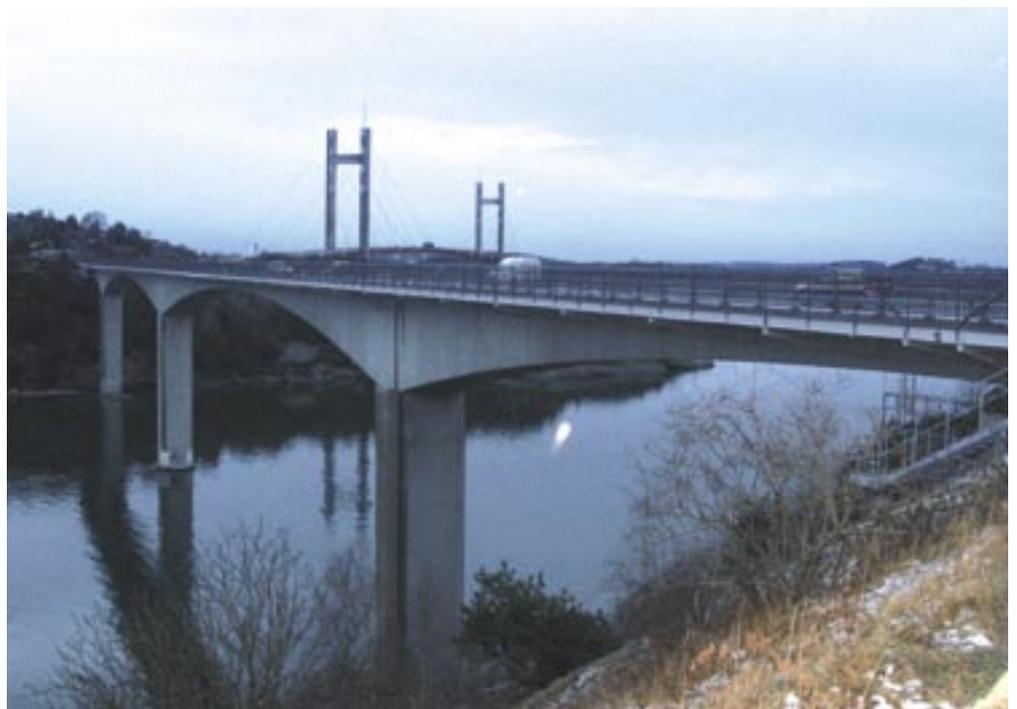
One of the two bridges that joins the island Tjörn with the mainland on the Swedish west coast has been strengthened with carbon fibre composite.

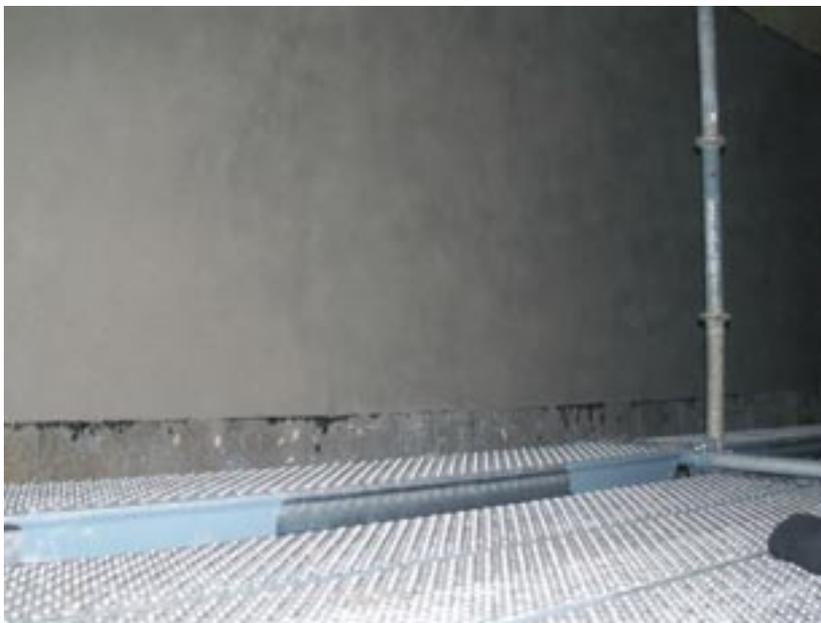
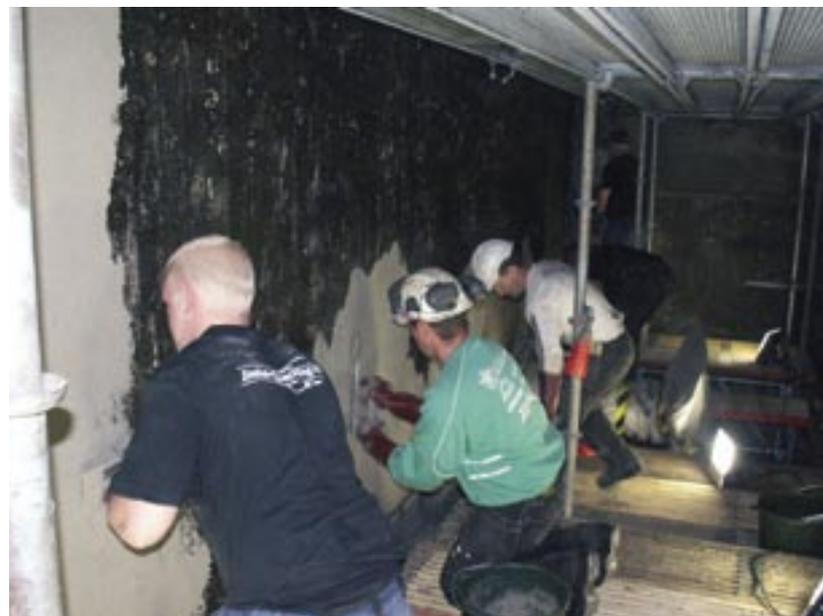
The concrete in the stock chest vat had disappeared... "COMPOSITE IS THE FUTURE"

Over five days the walls in the stock chest should be rebuilt with fast curing cement based repair material and then coated with composites.

ANOTHER stock chest had tiles instead of polyester, but this made no difference. It was still necessary to do something about it as the joints were in such a bad condition. The media had begun to penetrate the joints and the area behind the tiles, which made the tiles disengage from the concrete. Furthermore 200 millimetres of the concrete wall had disappeared...

It was far from simple, considering that 20 centimetres of the concrete had simply disappeared; dissolved by the aggressive sulphuric acid.

"Because sulfuric acid is added to the pulp, the temperature rises to over 70°C. The high temperature, in combination with the media, creates a very aggressive environment. The media penetrates and begins to dissolve the concrete. It is therefore the combination of temperature and in this case sulphuric acid which is the "bad man" in this drama. The result is that the concrete simply disappears.

"We used a material called fast curing MSS 470. It hardens very quickly (equivalent to a C50 concrete). After four hours it was possible to coat with the composite directly. We did the job within the contracted time" Greger Sohlman was pleased to confirm.
